IP Office Technical Bulletin

Bulletin No: 193
Release Date: 26 August 2016
Region: Global

General Availability (GA) - IP Office Release 9.0 Service Pack 12

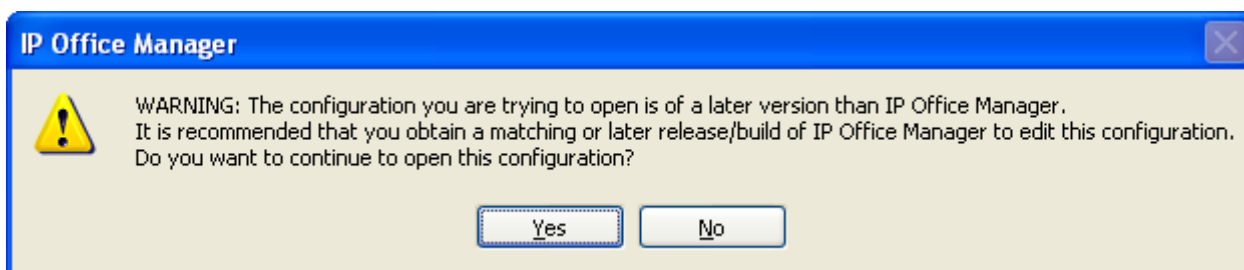
Earlier releases of IP Office 9.0 Manager are not compatible with systems running this release. Before upgrading an IP Office system to the 9.0.12.0.1006 release, the Administration suite must also be upgraded. The following message will be displayed if attempting to access a system running the 9.0.12.0.1006 release with an earlier version of Manager:

The IP Office Administration installer will detect previous installed versions and upgrade automatically. If a version earlier than 4.2 is installed, this must first be uninstalled before installing 9.0.12.0.1006. It is not necessary to restart the PC after upgrading unless instructed to do so. Before upgrading the IP Office system software ensure a backup of the system configuration exists.

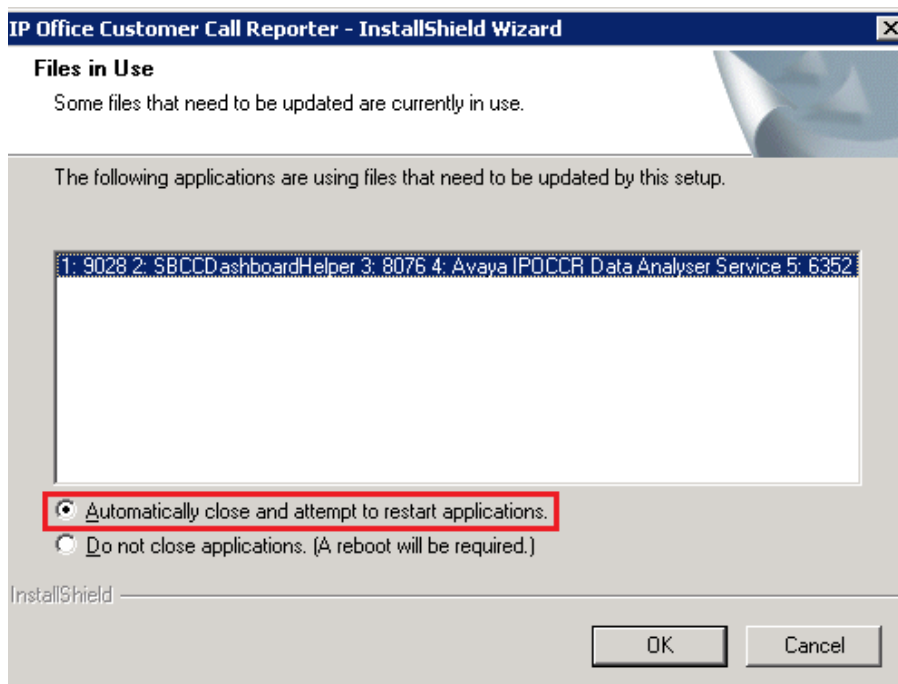
The following dialog box may be displayed during an upgrade to this release:

If this is displayed during the upgrade ensure that the highlighted option is selected and then click “OK”. The upgrade will then continue as normal.
