IP Office Technical Bulletin

Bulletin No: 179
Release Date: 05 June 2015
Region: Global

General Availability (GA) - IP Office Release 9.0 Service Pack 7

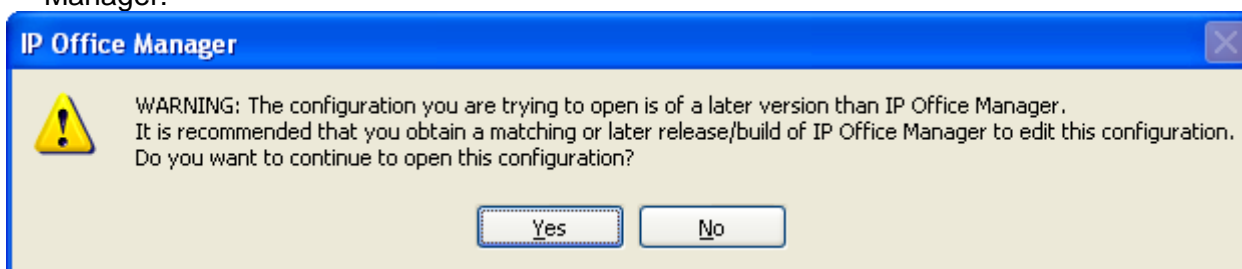
Earlier releases of IP Office 9.0 Manager are not compatible with systems running this release. Before upgrading an IP Office system to the 9.0.7.0.982 release, the Administration suite must also be upgraded. The following message will be displayed if attempting to access a system running the 9.0.7.0.982 release with an earlier version of Manager:

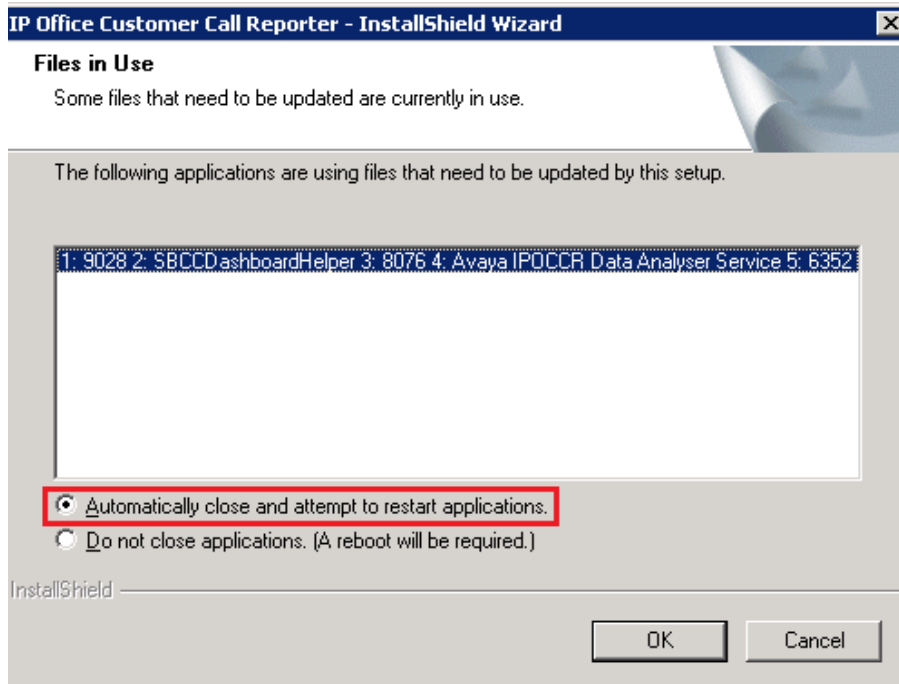
The following dialog box may be displayed during an upgrade to this release:

If this is displayed during the upgrade ensure that the highlighted option is selected and then click “OK”. The upgrade will then continue as normal.
