IP Office Technical Bulletin

Bulletin No: 181
Release Date: 24 June 2015
Region: Global

General Availability (GA) - IP Office Release 9.1 Service Pack 3

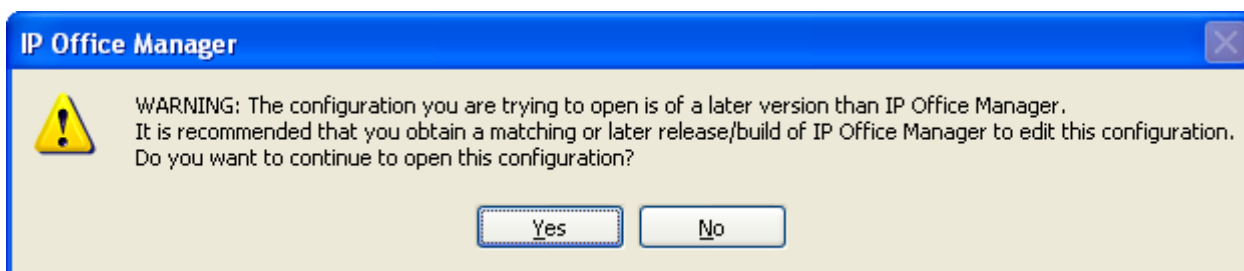
Earlier releases of IP Office 9.1 Manager are not compatible with systems running this release. Before upgrading an IP Office system to the 9.1.3.0.120 release, the Administration suite must also be upgraded. The following message will be displayed if attempting to access a system running the 9.1.3.0.120 release with an earlier version of Manager:

The IP Office Administration installer will detect previous installed versions and upgrade automatically. If a version earlier than 9.0 is installed, this must first be uninstalled before installing 9.1.3.0.120. It is not necessary to restart the PC after upgrading unless instructed to do so.
