IP Office Technical Bulletin

Bulletin No: 190
Release Date: 27 May 2016
Region: Global

General Availability (GA) - IP Office Release 9.1 Service Pack 7

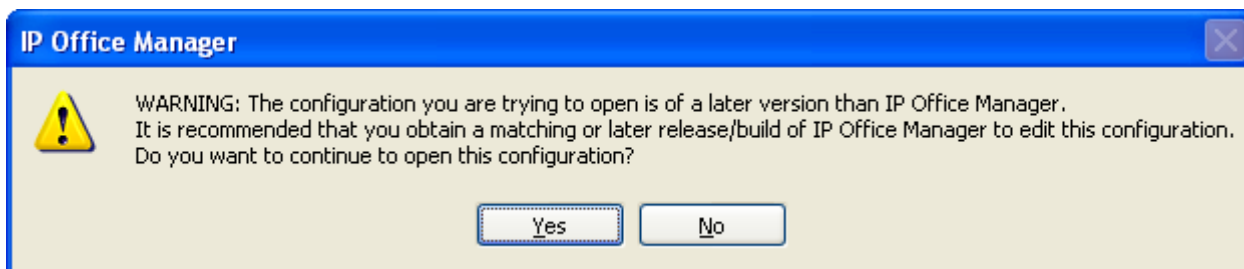
Earlier releases of IP Office 9.1 Manager are not compatible with systems running this release. Before upgrading an IP Office system to the 9.1.7.0.163 release, the Administration suite must also be upgraded. The following message will be displayed if

attempting to access a system running the 9.1.7.0.163 release with an earlier version of Manager:

The IP Office Administration installer will detect previous installed versions and upgrade automatically. If a version earlier than 9.0 is installed, this must first be uninstalled before installing 9.1.7.0.163. It is not necessary to restart the PC after upgrading unless instructed to do so.
