IP Office Technical Tip

Tip Number: 288

Unified Communications Module V2- Firmware Upgrade

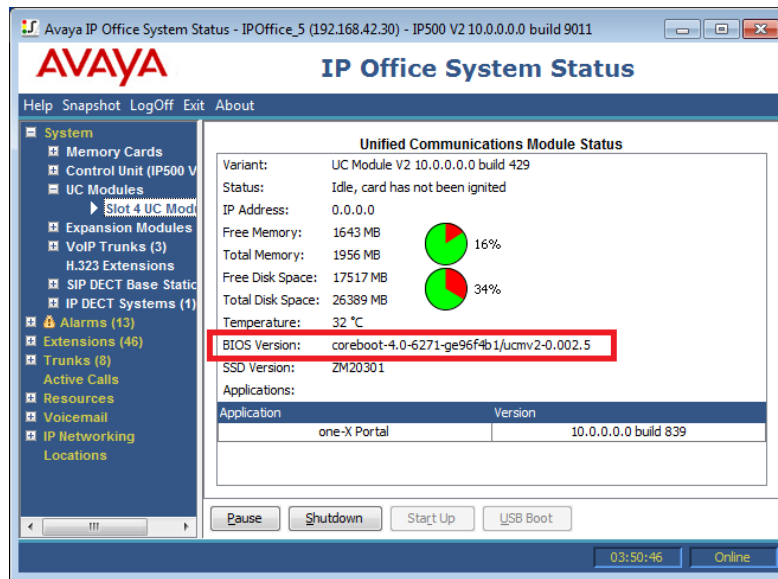
If the UCM V2 is installed in an operational IP Office system, the firmware version can be checked using System Status Application (SSA). Navigate to the UCM status screen and check the BIOS version field displayed. The latest version is “coreboot-4.0-6271-ge96f4b1/ucmv2-0.002.5”:

If an earlier version than the above is displayed, it is recommended that the upgrade process is followed to upgrade the firmware.

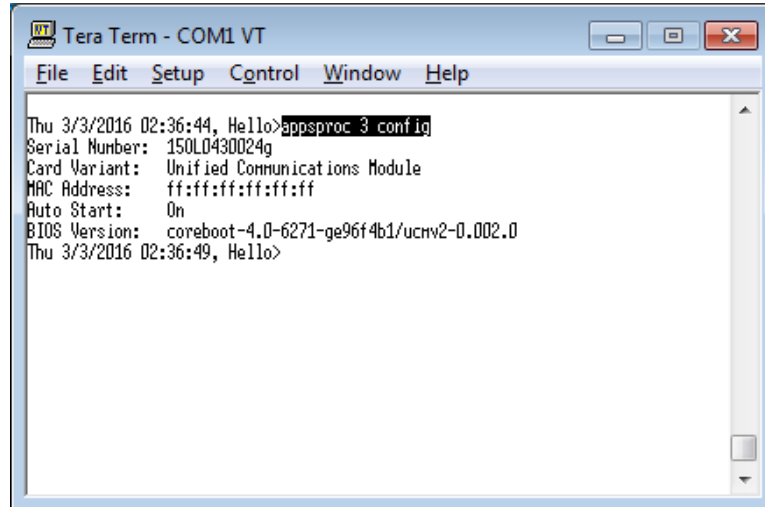
8. Check the BIOS version field for the required action:

```
coreboot-4.0-6271-ge96f4b1/ucmv2-0.002.0 – upgrade required
coreboot-4.0-6271-ge96f4b1/ucmv2-0.002.4 – upgrade required
coreboot-4.0-6271-ge96f4b1/ucmv2-0.002.5 – no upgrade required
```

If no upgrade is required, the procedure can finish here. Otherwise, continue with the next steps.

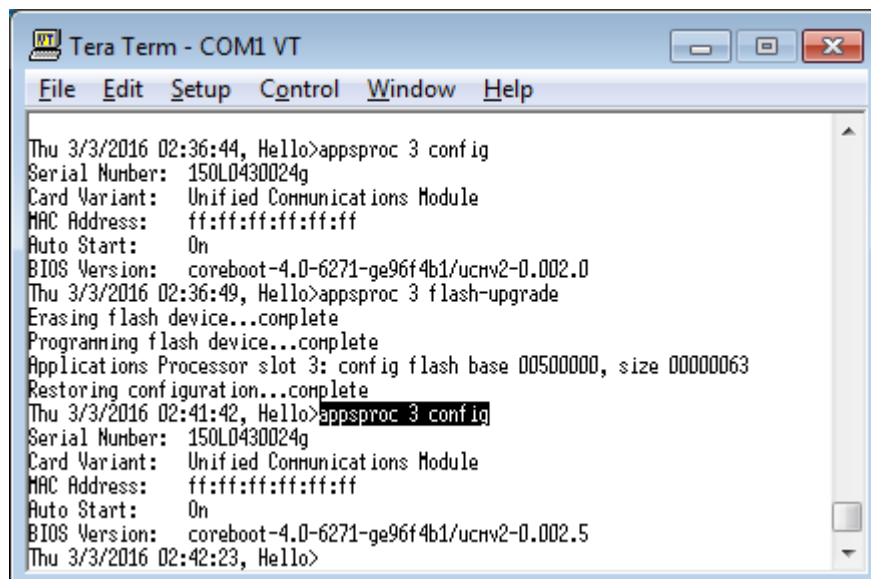
18. The erase and programming cycle will take approximately four minutes. On completion, enter the `appsproc <slot> config` command again and verify that the BIOS version displayed is now “coreboot-4.0-6271-ge96f4b1/ucmv2-0.002.5”:

19. The UCM V2 firmware upgrade is now complete. The card can be returned to service and powered on if previously commissioned, or the software installation procedure can now be followed to commission the card.
