IP Office Technical Bulletin

Bulletin No: 206
Release Date: 2nd June 2017
Region: Global

General Availability (GA) - IP Office Release 10.0 Service Pack 4

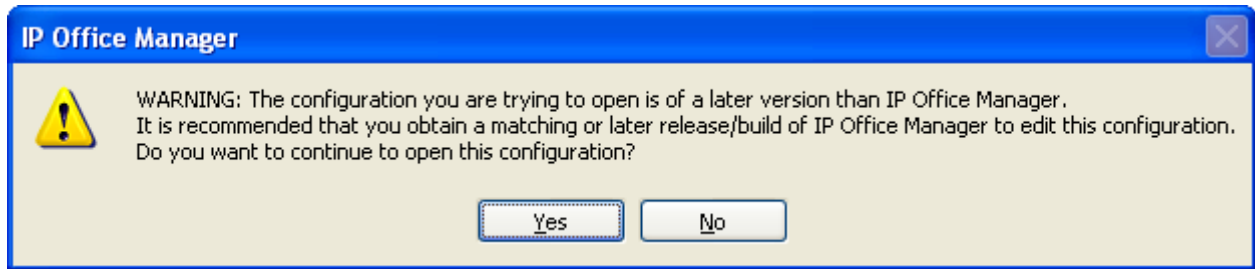
The previous GA release of IP Office 10.0 Manager is not compatible with systems running this release. Before upgrading an IP Office system to the 10.0.0.4.0.5 release, the Administration suite must also be upgraded. The

following message will be displayed if attempting to access a system running the 10.0.0.4.0.5 release with an earlier version of Manager:

The IP Office Administration installer will detect previous installed versions and upgrade automatically. If a version earlier than 9.0 is installed, this must first be uninstalled before installing 10.0.0.4.0.5. It is not necessary to restart the PC after upgrading unless instructed to do so.
