## IP Office Technical Bulletin

**Bulletin No:** 203  
**Release Date:** 2nd March 2017  
**Region:** Global

### **General Availability (GA) - IP Office Release 9.1 Service Pack 10**

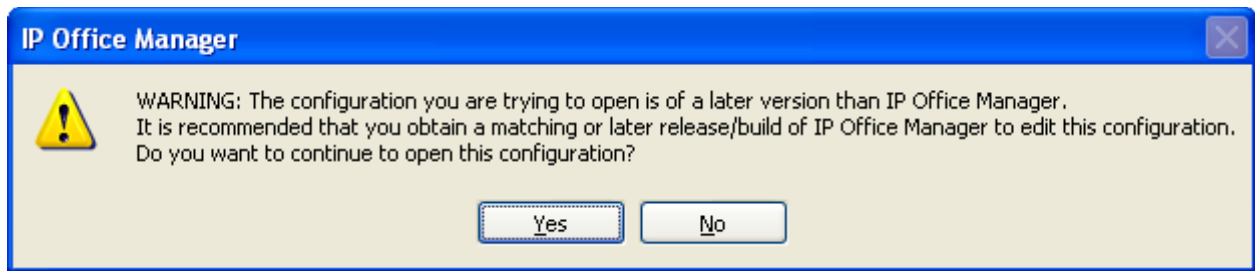
Earlier releases of IP Office 9.1 Manager are not compatible with systems running this release. Before upgrading an IP Office system to the 9.1.10.0.192 release, the Administration suite must also be upgraded. The following message will be displayed if attempting to access a system running the 9.1.10.0.192 release with an earlier version of Manager:

The IP Office Administration installer will detect previous installed versions and upgrade automatically. If a version earlier than 9.0 is installed, this must first be uninstalled before installing 9.1.10.0.192. It is not necessary to restart the PC after upgrading unless instructed to do so.
