## IP Office Technical Bulletin

**Bulletin No:** 177  
**Release Date:** 13 March 2015  
**Region:** Global

### General Availability (GA) - IP Office Release 9.0 Service Pack 6

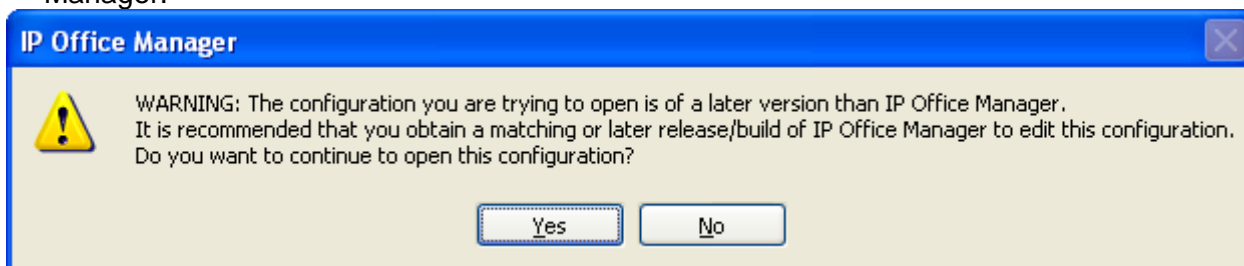
Earlier releases of IP Office 9.0 Manager are not compatible with systems running this release. Before upgrading an IP Office system to the 9.0.6.0.979 release, the Administration suite must also be upgraded. The following message will be displayed if attempting to access a system running the 9.0.6.0.979 release with an earlier version of Manager:

The IP Office Administration installer will detect previous installed versions and upgrade automatically. If a version earlier than 4.2 is installed, this must first be uninstalled before installing 9.0.6.0.979. It is not necessary to restart the PC after upgrading unless instructed to do so.

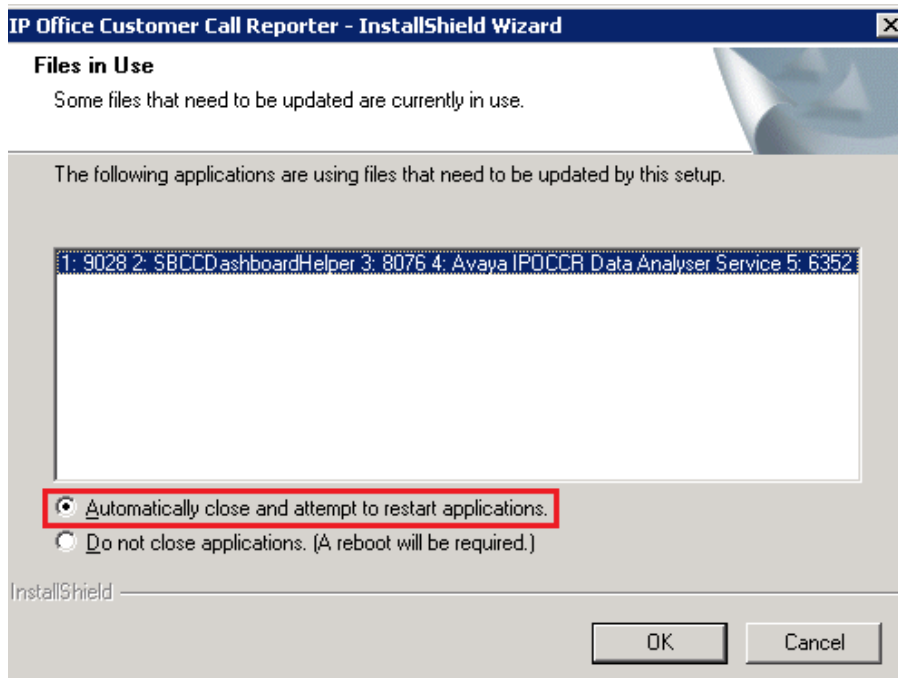
The following dialog box may be displayed during an upgrade to this release:

If this is displayed during the upgrade ensure that the highlighted option is selected and then click “OK”. The upgrade will then continue as normal.
