## IP Office Technical Bulletin

**Bulletin No:** 182  
**Release Date:** 04 September 2015  
**Region:** Global

### General Availability (GA) - IP Office Release 9.0 Service Pack 8

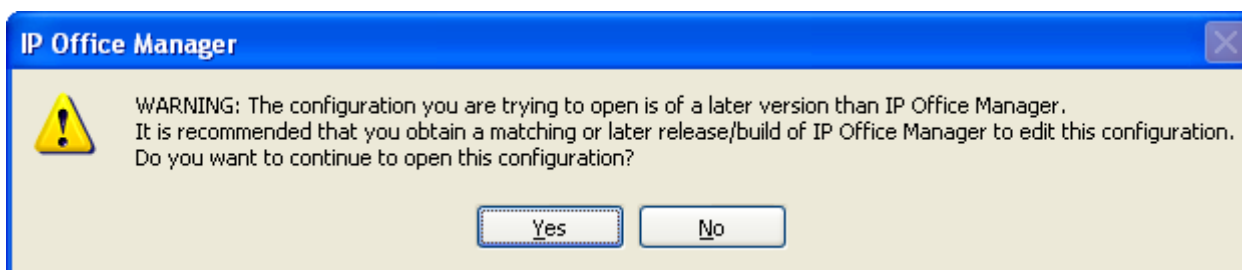
Earlier releases of IP Office 9.0 Manager are not compatible with systems running this release. Before upgrading an IP Office system to the 9.0.8.0.990 release, the Administration suite must also be upgraded. The following message will be displayed if attempting to access a system running the 9.0.8.0.990 release with an earlier version of Manager:

The IP Office Administration installer will detect previous installed versions and upgrade automatically. If a version earlier than 4.2 is installed, this must first be uninstalled before installing 9.0.8.0.990. It is not necessary to restart the PC after upgrading unless instructed to do so.
