## IP Office Technical Bulletin

**Bulletin No:** 192  
**Release Date:** 8 June 2016  
**Region:** Global

### General Availability (GA) - IP Office Release 9.0 Service Pack 11

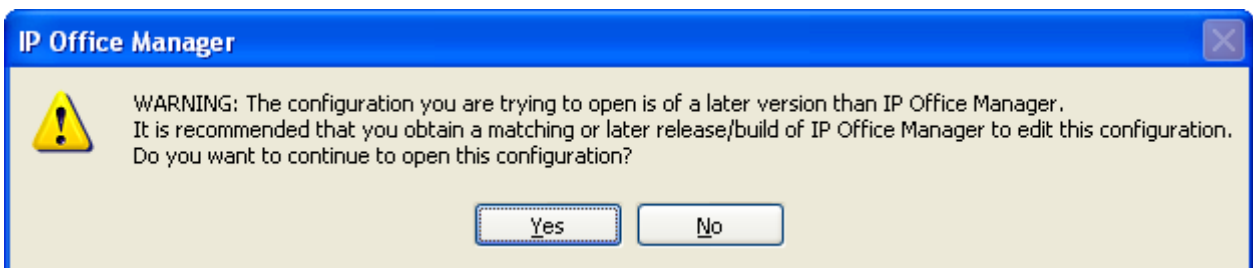
Earlier releases of IP Office 9.0 Manager are not compatible with systems running this release. Before upgrading an IP Office system to the 9.0.11.0.1003 release, the Administration suite must also be upgraded. The following message will be displayed if attempting to access a system running the 9.0.11.0.1003 release with an earlier version of Manager:

The IP Office Administration installer will detect previous installed versions and upgrade automatically. If a version earlier than 4.2 is installed, this must first be uninstalled before installing 9.0.11.0.1003. It is not necessary to restart the PC after upgrading unless instructed to do so. Before upgrading the IP Office system software ensure a backup of the system configuration exists.
