IP Office Technical Bulletin

Bulletin No: 196
Release Date: 28 September 2016
Region: Global

General Availability (GA) - IP Office Release 10.0 Service Pack 1

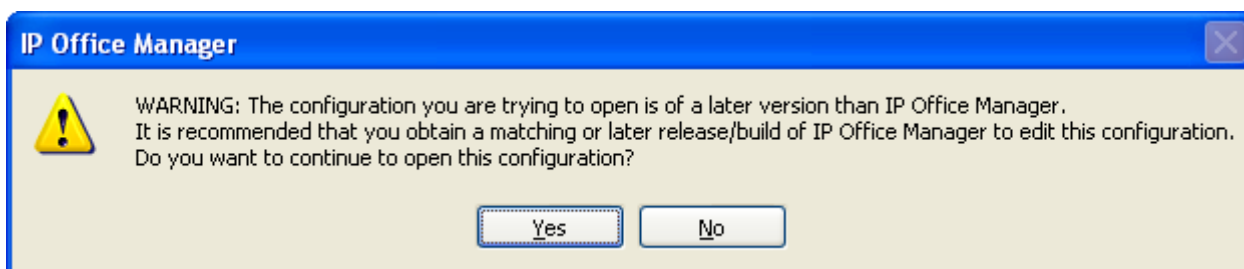
The previous GA release of IP Office 10.0 Manager is not compatible with systems running this release. Before upgrading an IP Office system to the 10.0.0.1.0.53 release, the Administration suite must also be upgraded. The following message will be displayed if attempting to access a system running the 10.0.0.1.0.53 release with an earlier version of Manager:

The IP Office Administration installer will detect previous installed versions and upgrade automatically. If a version earlier than 9.0 is installed, this must first be uninstalled before installing 10.0.0.1.0.53. It is not necessary to restart the PC after upgrading unless instructed to do so.
