## IP Office Technical Bulletin

**Bulletin No:** 43  
**Date:** 30 June 2005  
**Region:** Global

<i>General Availability (GA) of the IP Office 3.0 June Maintenance release</i>	2
1 <i>Overview</i>	2
2 <i>New Feature Support</i>	2
3 <i>IP Office Resolved Field Issues</i>	3

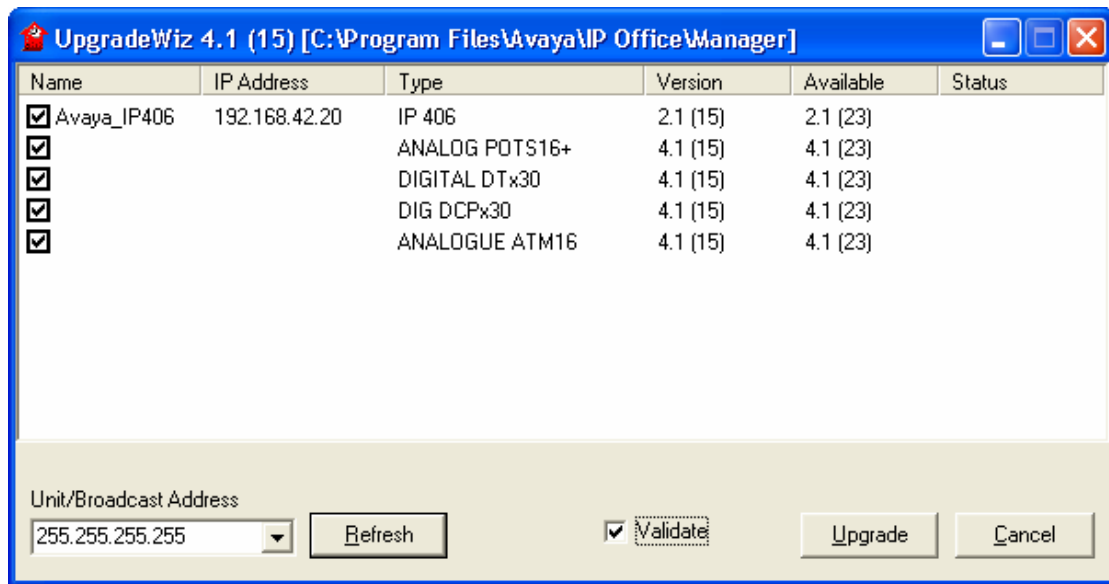
1. Ensure that you have received and made a backup copy of the latest IP Office configuration. If for any reason the upgrade fails the current configuration may be erased, so a backup copy is essential.
2. In Manager select File | Advanced | Upgrade. This will start the UpgradeWiz application.
3. After a few seconds the upgrade wizard should show the Control and Expansion units found.
4. If no units are found using the broadcast address 255.255.255.255 this implies that the Manager PC is not on the same LAN as the IP Office. You should not continue in this case until you identify a Manager PC on the same LAN as the IP Office.
5. A window similar to the following is displayed. The list shows the current software levels of the units and the level of the appropriate bin file that is available in the Manager/Binary working directories.

6. The current version and available versions are displayed. Tick the check box under Name if it is not already ticked then click on Upgrade.
7. Enter the password of the existing configuration (not the default). Click OK and IP Office will reboot and undergo the upgrade cycle. This takes around a minute to complete. Click OK to finish once the upgrade has completed. This will close the UpgradeWiz window.

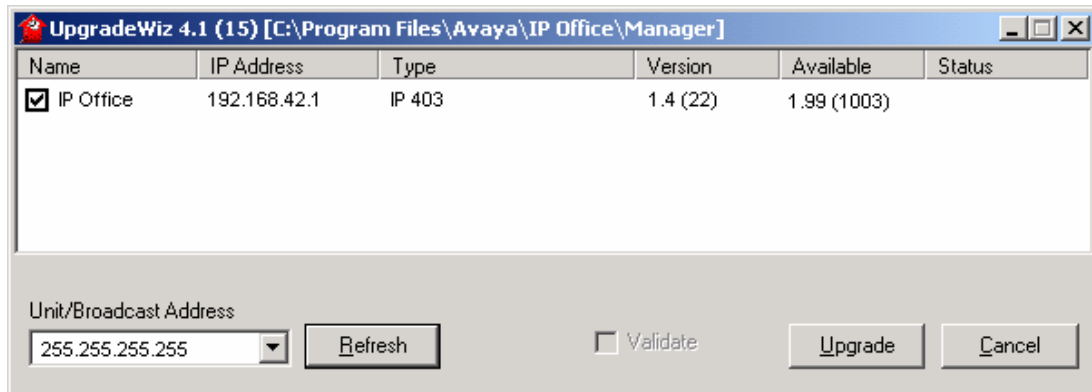
7. A window similar to the one below is displayed. The list shows the current software levels of the units and the level of the appropriate bin file that is available in the Manager/Binary working directories.

8. The current version and available versions are displayed. Tick the check box under Name if it is not already ticked then click on Upgrade.
9. Enter the password of the existing configuration (not the default). Click OK and IP Office will reboot and undergo the upgrade cycle. This takes around a minute to complete. Click OK to finish once the upgrade has completed. This will close the UpgradeWiz window.

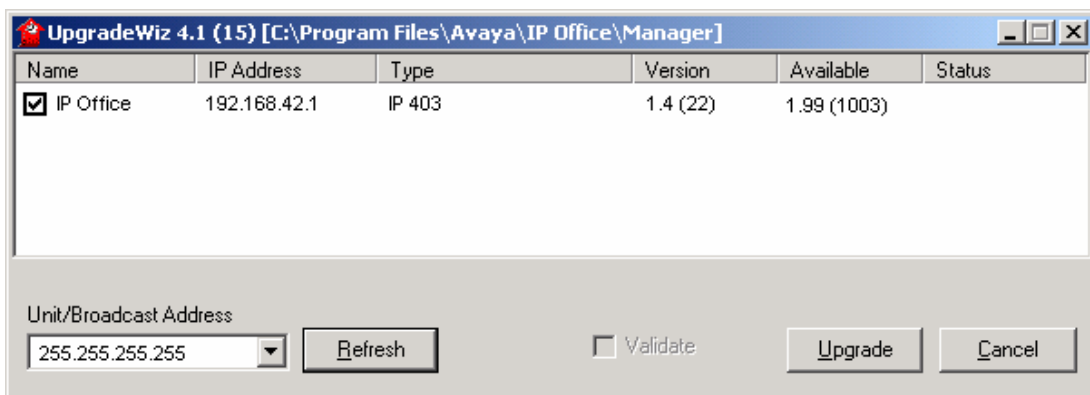
3. Open the Manager and ensure that you have received and made a backup copy of the latest IP Office configuration. If for any reason the upgrade fails, the current configuration may be erased, so a backup copy is essential.
4. In Manager select File | Advanced | Upgrade. This will start the UpgradeWiz application.
5. After a few seconds the upgrade wizard should show the Control and Expansion units found.
6. If no units are found using the broadcast address 255.255.255.255, this implies that the Manager PC is not on the same LAN as the IP Office. You should not continue in this case until you identify a Manager PC on the same LAN as the IP Office.
7. A window similar to the one below is displayed. The list shows the current software levels of the units and the level of the appropriate bin file that is available in the Manager/Binary working directories.

8. The current version and available versions are displayed. Tick the check box under Name if it is not already ticked then click on Upgrade.
9. Enter the password of the existing configuration (not the default). Click OK and IP Office will reboot and undergo the upgrade cycle. This takes around a minute to complete. Click OK to finish once the upgrade has completed. This will close the UpgradeWiz window.
