## IP Office Technical Bulletin

**Bulletin No:** 50  
**Date:** 27 September 2005  
**Region:** Global

### General Availability (GA) of the Avaya IP Office 3.0DT September Maintenance Release

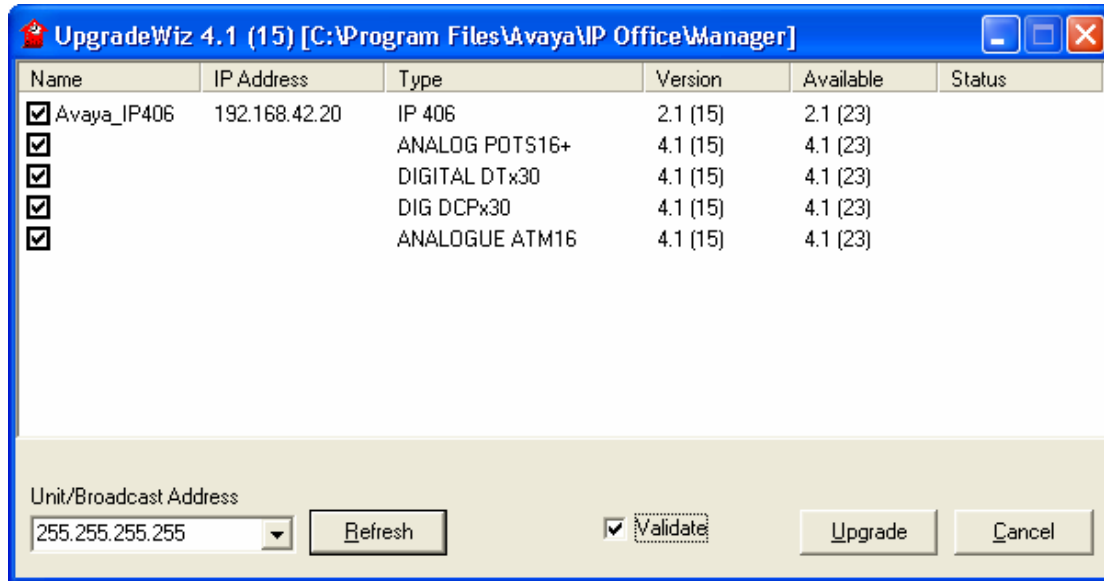
1. Ensure that you have received and made a backup copy of the latest IP Office configuration. If for any reason the upgrade fails the current configuration may be erased, so a backup copy is essential.
2. In Manager select File | Advanced | Upgrade. This will start the UpgradeWiz application.
3. After a few seconds the upgrade wizard should show the Control and Expansion units found.
4. If no units are found using the broadcast address 255.255.255.255 this implies that the Manager PC is not on the same LAN as the IP Office. You should not continue in this case until you identify a Manager PC on the same LAN as the IP Office.
5. A window similar to the following is displayed. The list shows the current software levels of the units and the level of the appropriate bin file that is available in the Manager/Binary working directories.

6. The current version and available versions are displayed. Tick the check box under Name if it is not already ticked then click on Upgrade.
7. Enter the password of the existing configuration (not the default). Click OK and IP Office will reboot and undergo the upgrade cycle. This takes around a minute to complete. Click OK to finish once the upgrade has completed. This will close the UpgradeWiz window.

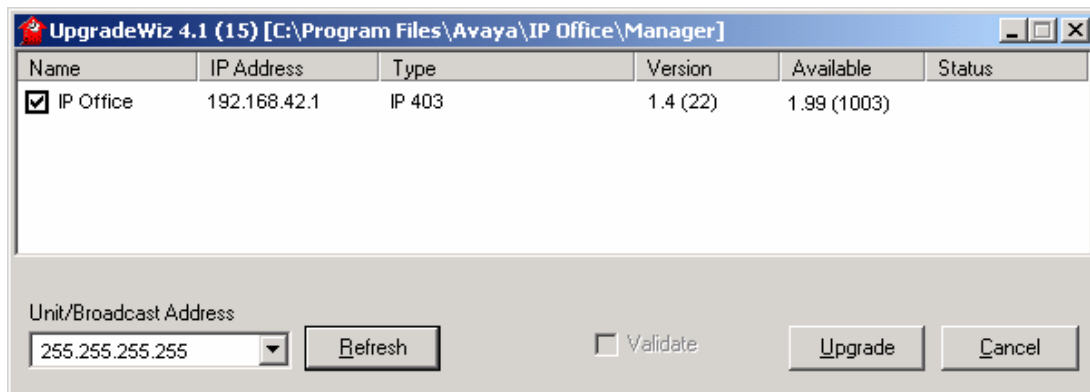
6. If no units are found using the broadcast address 255.255.255.255, this implies that the Manager PC is not on the same LAN as the IP Office. You should not continue in this case until you identify a Manager PC on the same LAN as the IP Office.
7. A window similar to the one below is displayed. The list shows the current software levels of the units and the level of the appropriate bin file that is available in the Manager/Binary working directories.

8. The current version and available versions are displayed. Tick the check box under Name if it is not already ticked then click on Upgrade.
9. Enter the password of the existing configuration (not the default). Click OK and the IP Office will reboot and undergo the upgrade cycle. This takes around a minute to complete. Click OK to finish once the upgrade has completed. This will close the UpgradeWiz window.

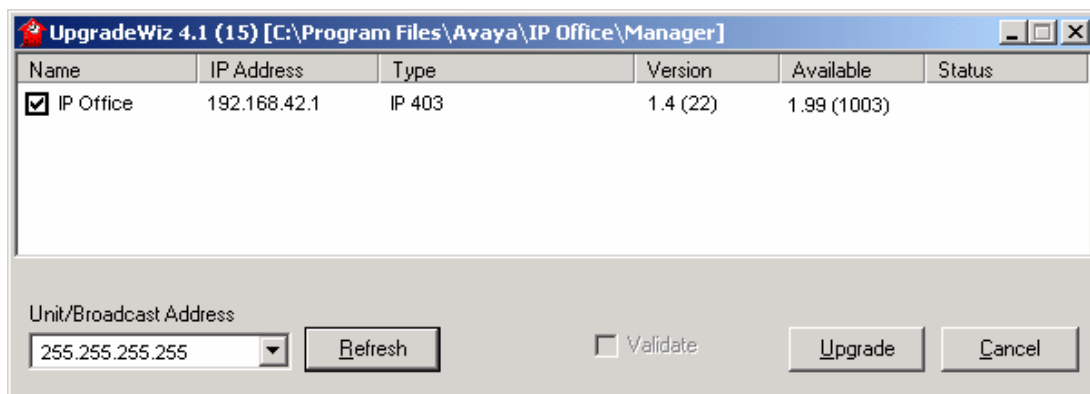
3. Open the Manager and ensure that you have received and made a backup copy of the latest IP Office configuration. If for any reason the upgrade fails, the current configuration may be erased, so a backup copy is essential.
4. In Manager select File | Advanced | Upgrade. This will start the UpgradeWiz application.
5. After a few seconds the upgrade wizard should show the Control and Expansion units found.
6. If no units are found using the broadcast address 255.255.255.255, this implies that the Manager PC is not on the same LAN as the IP Office. You should not continue in this case until you identify a Manager PC on the same LAN as the IP Office.
7. A window similar to the one below is displayed. The list shows the current software levels of the units and the level of the appropriate bin file that is available in the Manager/Binary working directories.

8. The current version and available versions are displayed. Tick the check box under Name if it is not already ticked then click on Upgrade.
9. Enter the password of the existing configuration (not the default). Click OK and IP Office will reboot and undergo the upgrade cycle. This takes around a minute to complete. Click OK to finish once the upgrade has completed. This will close the UpgradeWiz window.
