IP Office Technical Bulletin

Bulletin No: 55
Date: 15 December 2005
Region: Global

General Availability (GA) of the Avaya IP Office 3.0DT December Maintenance Release

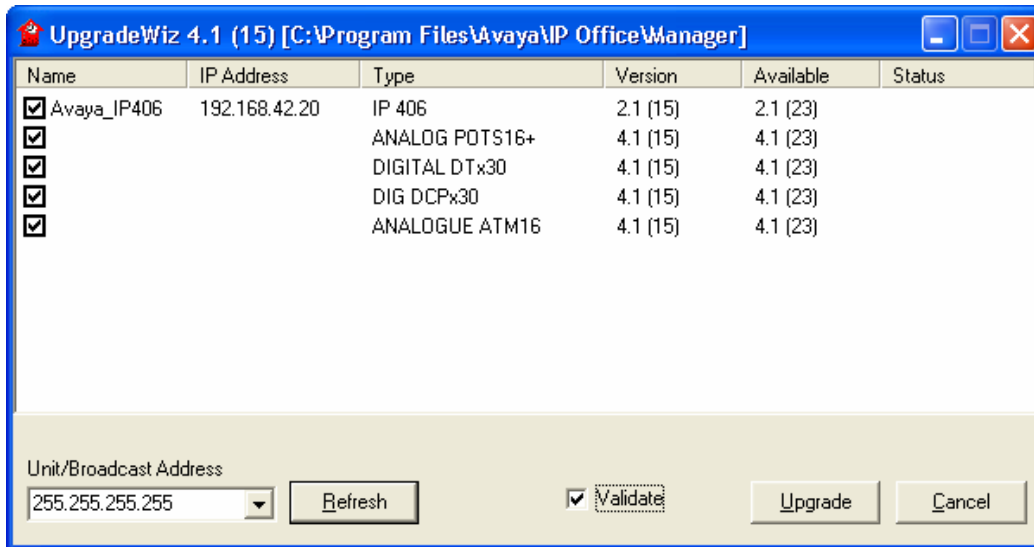
1. Ensure that you have received and made a backup copy of the latest IP Office configuration. If for any reason the upgrade fails the current configuration may be erased, so a backup copy is essential.
2. In Manager select File | Advanced | Upgrade. This will start the UpgradeWiz application.
3. After a few seconds the upgrade wizard should show the Control and Expansion units found.
4. If no units are found using the broadcast address 255.255.255.255 this implies that the Manager PC is not on the same LAN as the IP Office. You should not continue in this case until you identify a Manager PC on the same LAN as the IP Office.
5. A window similar to the following is displayed. The list shows the current software levels of the units and the level of the appropriate bin file that is available in the Manager/Binary working directories.

6. The current version and available versions are displayed. Tick the check box under Name if it is not already ticked then click on Upgrade.
7. Enter the password of the existing configuration (not the default). Click OK and IP Office will reboot and undergo the upgrade cycle. This takes around a minute to complete. Click OK to finish once the upgrade has completed. This will close the UpgradeWiz window.

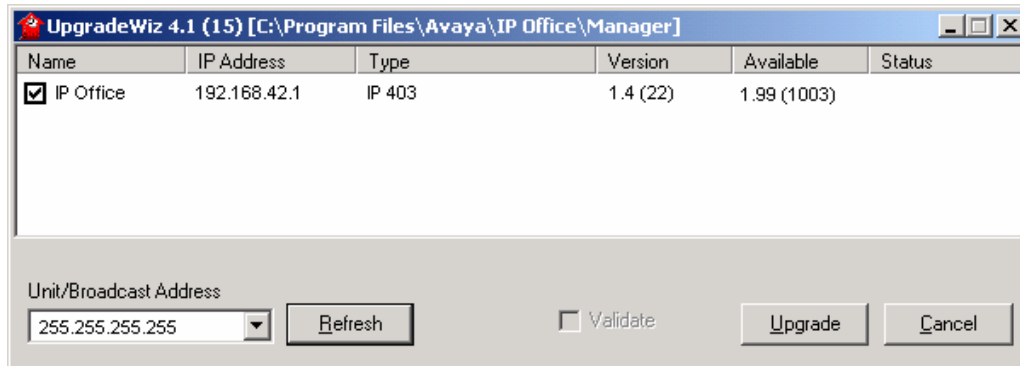
6. If no units are found using the broadcast address 255.255.255.255, this implies that the Manager PC is not on the same LAN as the IP Office. You should not continue in this case until you identify a Manager PC on the same LAN as the IP Office.
7. A window similar to the one below is displayed. The list shows the current software levels of the units and the level of the appropriate bin file that is available in the Manager/Binary working directories.

8. The current version and available versions are displayed. Tick the check box under Name if it is not already ticked then click on Upgrade.
9. Enter the password of the existing configuration (not the default). Click OK and the IP Office will reboot and undergo the upgrade cycle. This takes around a minute to complete. Click OK to finish once the upgrade has completed. This will close the UpgradeWiz window.

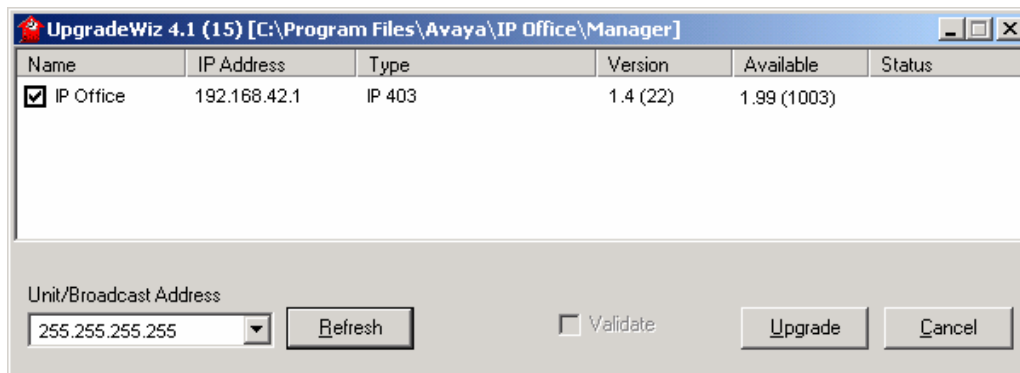
3. Open the Manager and ensure that you have received and made a backup copy of the latest IP Office configuration. If for any reason the upgrade fails, the current configuration may be erased, so a backup copy is essential.
4. In Manager select File | Advanced | Upgrade. This will start the UpgradeWiz application.
5. After a few seconds the upgrade wizard should show the Control and Expansion units found.
6. If no units are found using the broadcast address 255.255.255.255, this implies that the Manager PC is not on the same LAN as the IP Office. You should not continue in this case until you identify a Manager PC on the same LAN as the IP Office.
7. A window similar to the one below is displayed. The list shows the current software levels of the units and the level of the appropriate bin file that is available in the Manager/Binary working directories.

8. The current version and available versions are displayed. Tick the check box under Name if it is not already ticked then click on Upgrade.
9. Enter the password of the existing configuration (not the default). Click OK and IP Office will reboot and undergo the upgrade cycle. This takes around a minute to complete. Click OK to finish once the upgrade has completed. This will close the UpgradeWiz window.
