## IP Office Technical Bulletin

**Bulletin No:** 79  
**Date:** 28 February 2007  
**Region:** Global

### **General Availability (GA) of the Avaya IP Office 3.0DT Q1 2007 Maintenance Release**

Avaya is pleased to announce the availability of IP Office 3.0DT 3.0(578) Software. This is a scheduled release introducing additional functionality and addressing a number of identified issues found in the IP Office 3.0DT release.

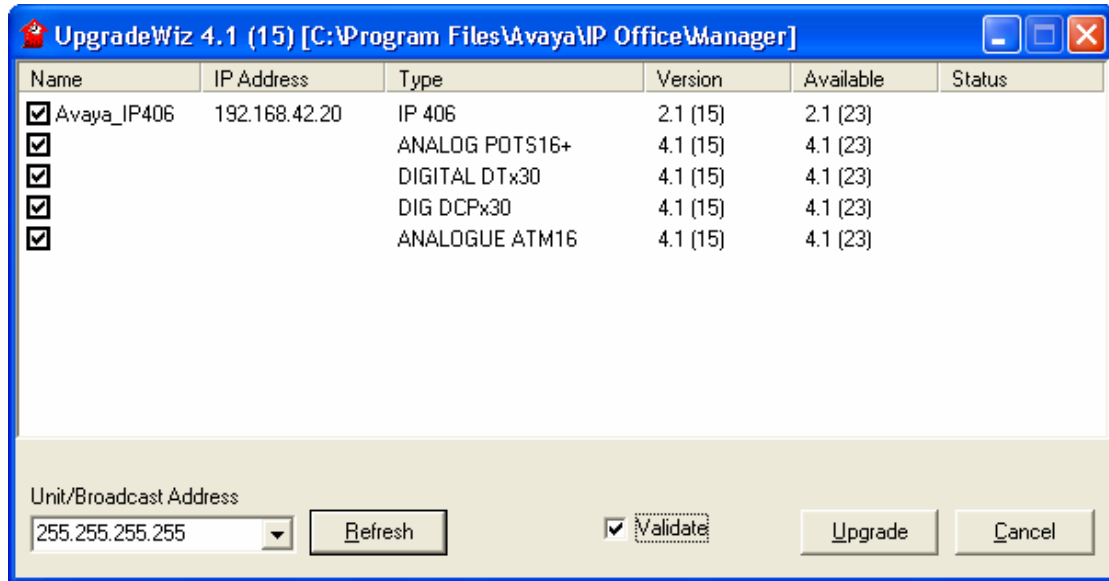
1. Ensure that you have received and made a backup copy of the latest IP Office configuration. If for any reason the upgrade fails the current configuration may be erased, so a backup copy is essential.
2. In Manager select File | Advanced | Upgrade. This will start the UpgradeWiz application.
3. After a few seconds the upgrade wizard should show the Control and Expansion units found.
4. If no units are found using the broadcast address 255.255.255.255 this implies that the Manager PC is not on the same LAN as the IP Office. You should not continue in this case until you identify a Manager PC on the same LAN as the IP Office.
5. A window similar to the following is displayed. The list shows the current software levels of the units and the level of the appropriate bin file that is available in the Manager/Binary working directories.

6. The current version and available versions are displayed. Tick the check box under Name if it is not already ticked then click on Upgrade.
7. Enter the password of the existing configuration (not the default). Click OK and IP Office will reboot and undergo the upgrade cycle. This takes around a minute to complete. Click OK to finish once the upgrade has completed. This will close the UpgradeWiz window.
